Nylon Fibres Eliminate and Silica Fume Does Not Increase the Risk of Explosive Spalling of HPC In Fire

Report By : Frank Papworth

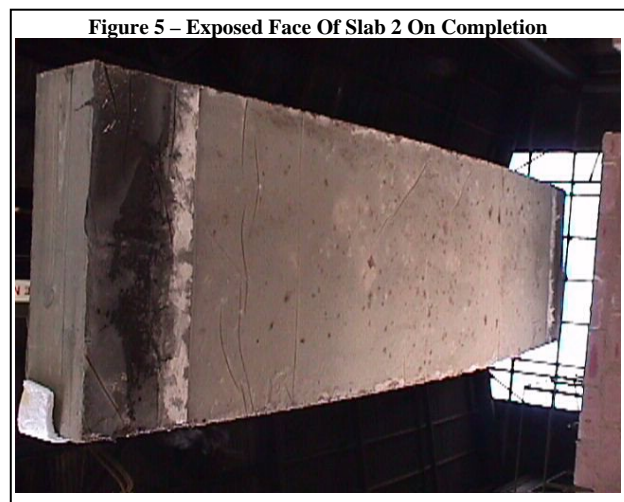
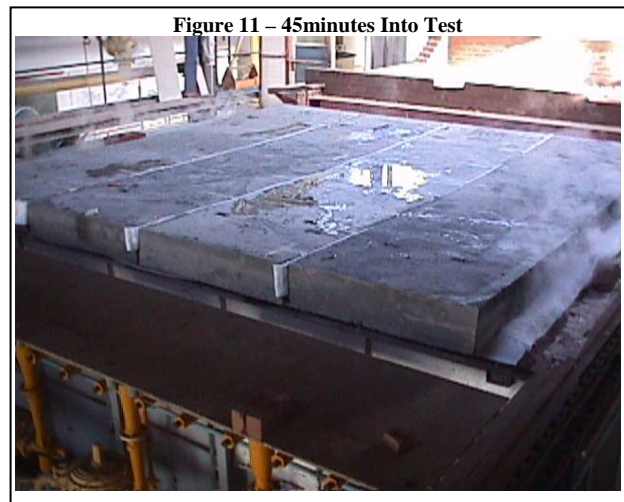
The observations made during the fire-resistance test are shown in table 3 and photographs are shown in figs 4-11.

Table 3 –Observations During The Fire Test	
Time (mins)	CSIRO Observation
10	General spalling sounds are audible from the slabs.
15	It appears that exposed sides of slabs 1,3 & 4 are spalling. Moisture is forming along the exposed edges of all the slabs.
20	Moisture is forming on top of slab 2.
25	Exposed face of slab 3 appears to be spalling the most, while the underside of slab 2 appears to be unaffected.
40	Spalling sounds appear to have stopped.
45	Moisture patches are appearing on top of slabs 1 & 4.
60	No apparent change to the specimens.
120	Test terminated. Examination of the specimens after the termination of the test showed slab 2 had hair cracks but only otherwise substantially unaffected. Slabs 1, 3 & 4 showed significant spelling.

The testing showed no difference in the performance of 0, 5 and 10% silica fume concrete in terms of explosive spalling, they all failed badly. This fact gives serious concern for the performance of concrete in a fire in a tunnel. The Nycon fibres proved extremely effective in eliminating the risk of explosive spalling. Only a few aggregate popouts occurred. In addition to providing protection to this type of failure the fibres will provide resistance to edge damage during handling and plastic crack control.
